2003 Supplement
to the
Large Whale Gear Research Summary
April, 2003

2003 Supplement
to the
Large Whale Gear Research Summary

Glenn Salvador¹, John Kenney² & John Higgins³
April, 2003

NOAA/Fisheries, Northeast Region
Protected Resources Division
Gear Research Team

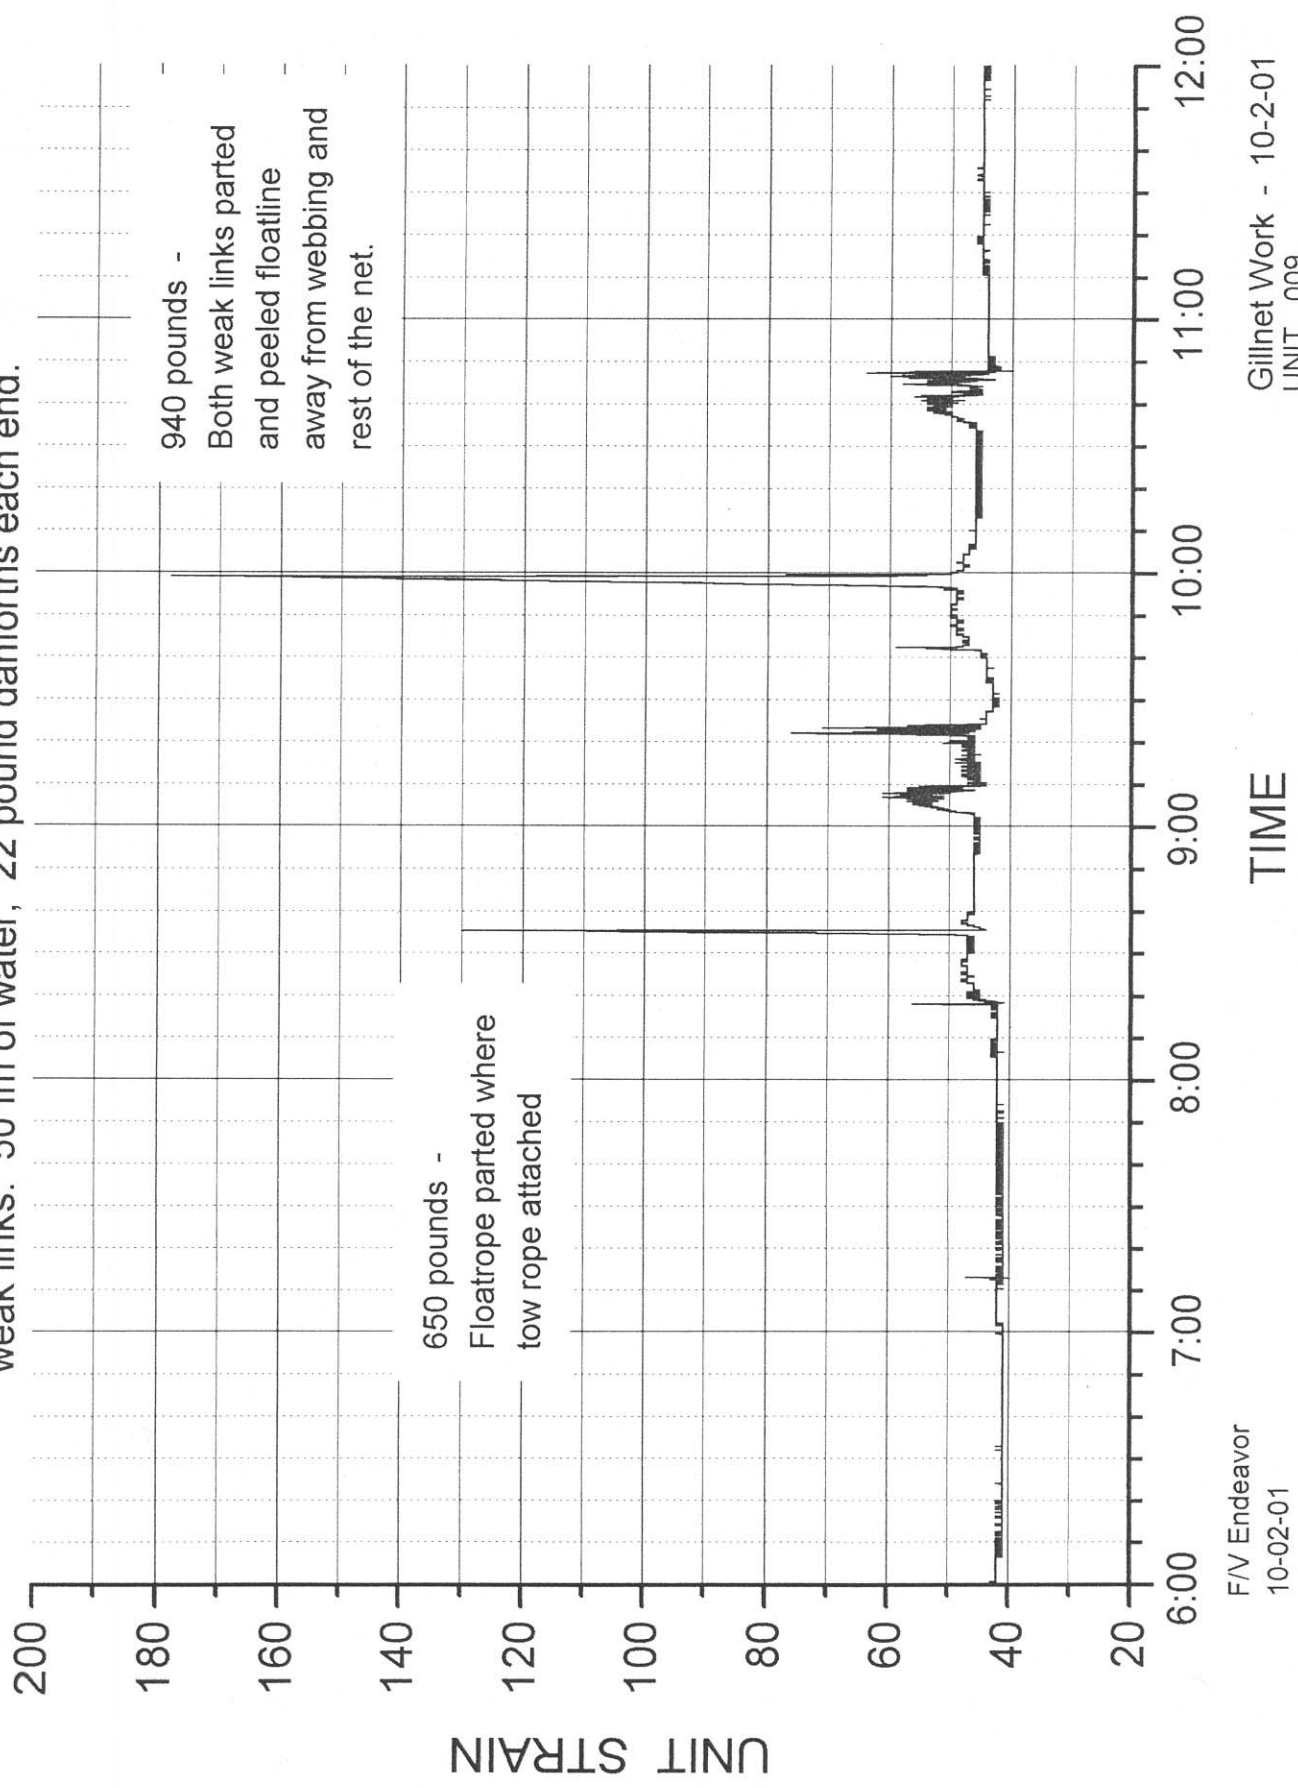
Gillnet Work - 10-2-01
UNIT 009

LC-41
Load cell located between nets 7 & 8 in floatrope of 15 net string.
Tow rope tied into floatrope of net 7 between two 1100 pound
weak links. 50 fm of water, 22 pound danforths each end.

8:20 Begin set 15 net string with 22lb danforth anchors in 50 fathom of water, string set north and south. Load cell tied between net 7 and 8 on floatline. Tow line tied on floatline of 7th net in between 2 weak links (this net had three 1100lb weak links of 5/16" poly, the links were at the 12th, 24th and 36th floats). Sea conditions 6 - 8 foot swell with 10 knots of west wind.

10:05 both 1100lb weak links broke and peeled floatline away from webbing and rest of net
